Work on St John-in-Bedwardine Church Tower Progress on Roof at 16th May 2011

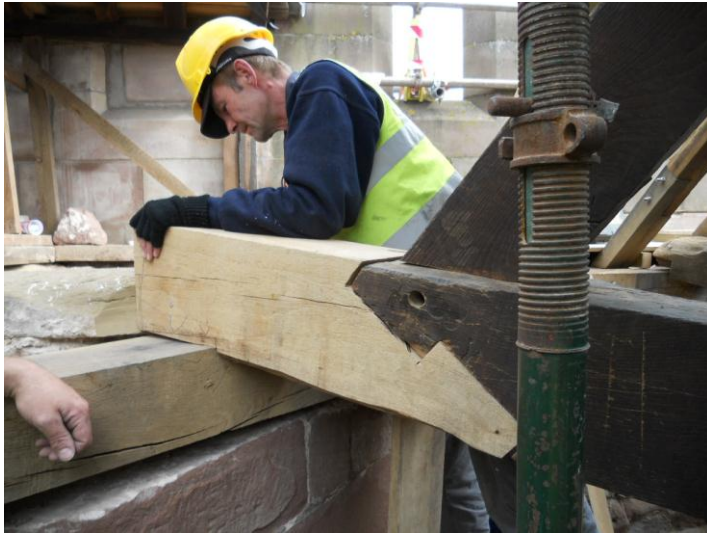
There are three aspects to this project; the **roof repair**, work on the **bell frame**, and refurbishment of the **clock**. The work is taking longer than anticipated because more rotten wood was found in the roof when the restoration began.

Now that the decayed wood has been cut away, Kevin the carpenter is joining new oak to the existing wood. This is a Tabled Scarf Joint.

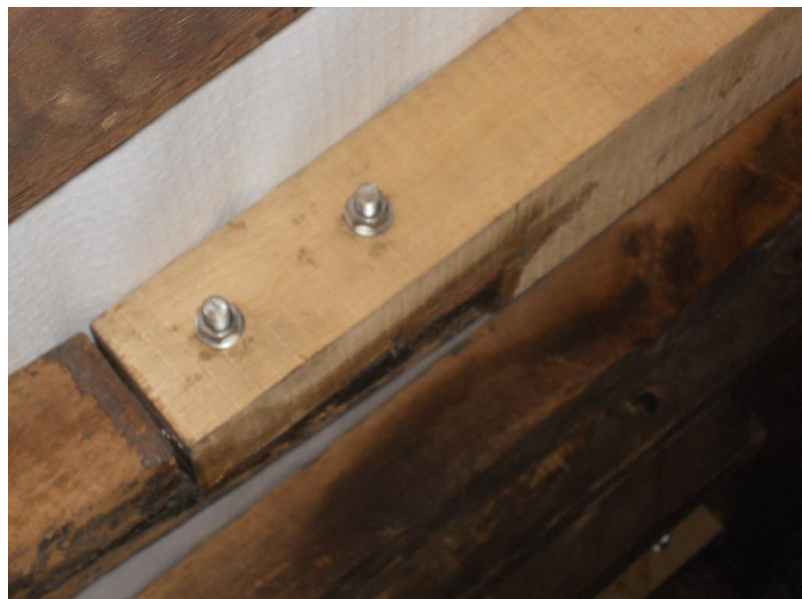
A new joint.

All the rafters required replacement. They are fixed to the new timber wall plate.

The metal strap will lend strength to the joint with the old timber.

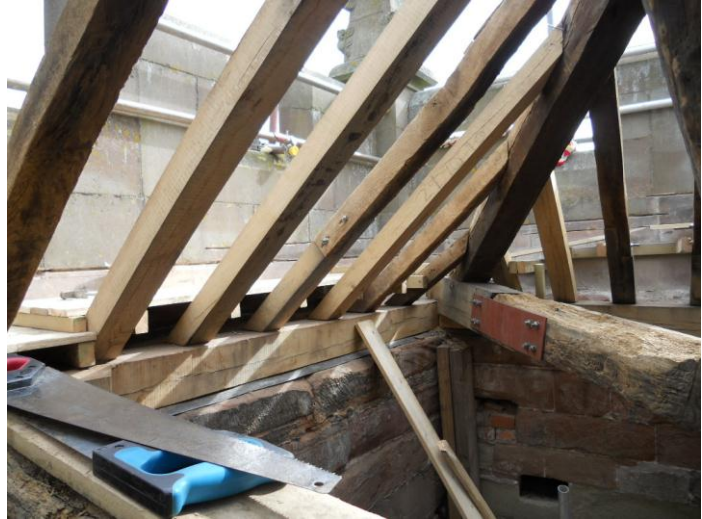
Inside the roof, the damp atmosphere which allowed the rot to thrive has been eradicated, and breathable synthetic felting covers the timbers.

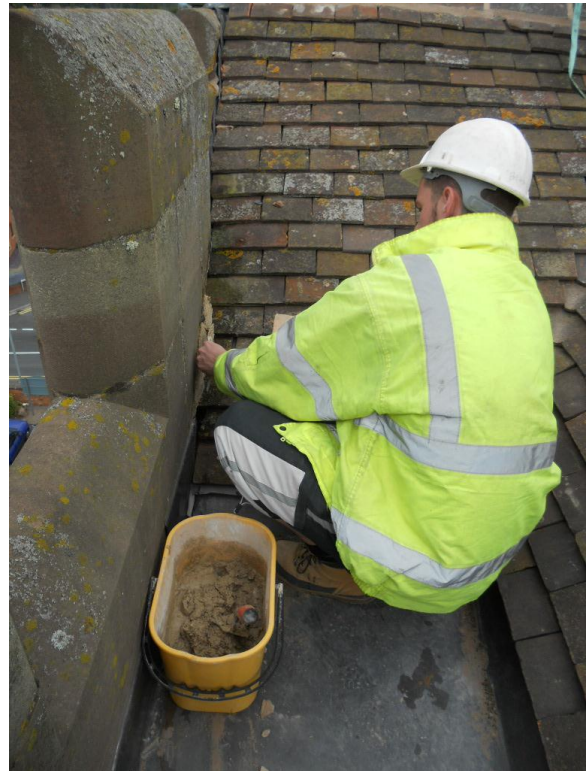
Now that the tiles have been replaced, repairs to the roof are complete and the contractor can commence work at belfry level.
