**ST JOHN-IN-BEDWARDINE CHURCH
TOWER APPEAL**

PROJECT DIARY

November 2007 – March 2012

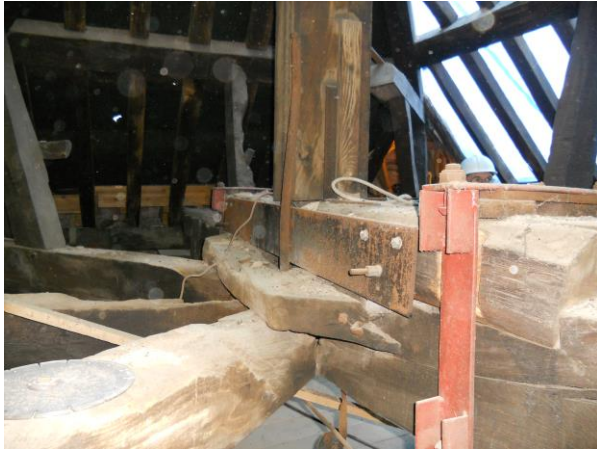
This picture was taken inside the steeple. The tower was struck by lightning many years ago, cracking the oak beam. Here you can see the metal repair put up by an agile and fearless Arthur Lee, who had to access the beam from underneath and work from a ladder.

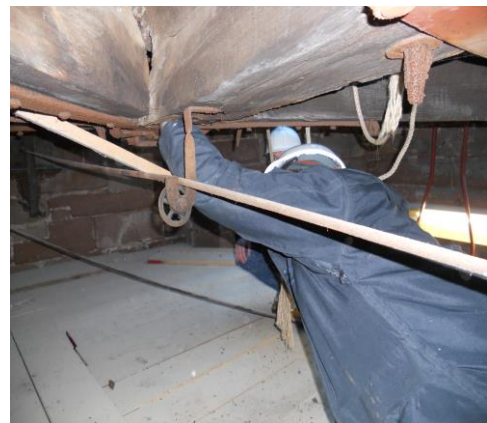
The death watch beetle damage is extensive; this huge oak beam is quite hollow. Mark can reach right inside it.

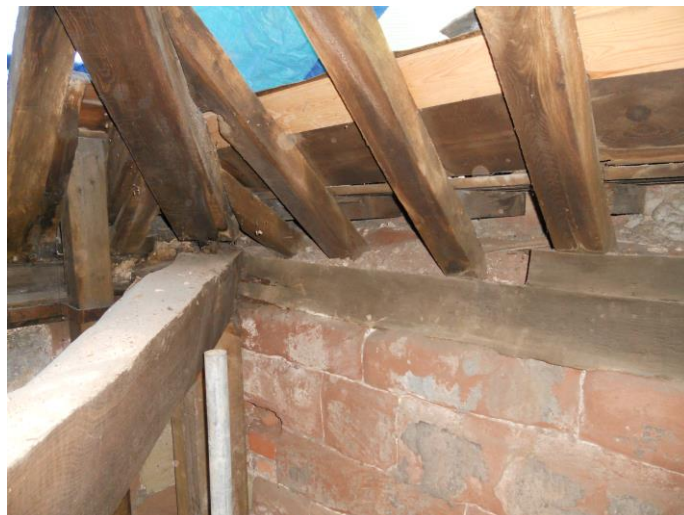
Still inside the steeple, the wall-plate timber has sunk into the stonework.

This happens when the timber becomes very wet. It rots and releases tannic acid, dissolving the red sandstone.

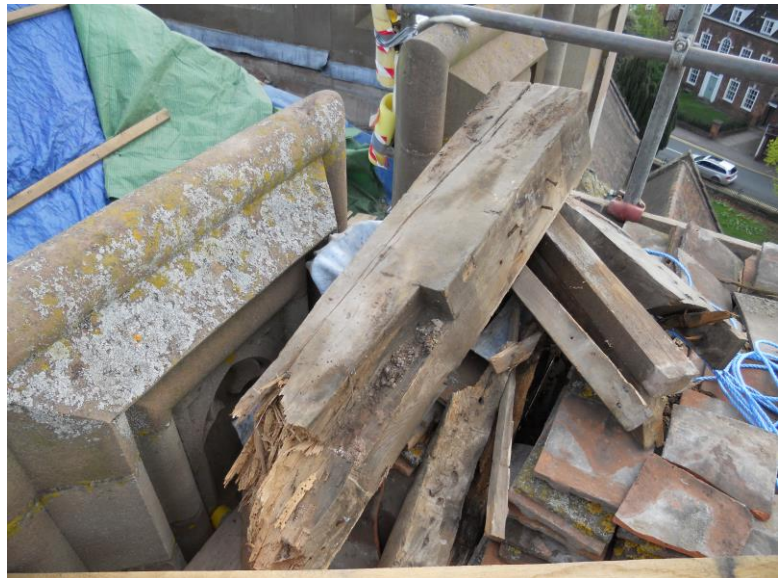
The rotten wood is removed. This is death-watch beetle damage...

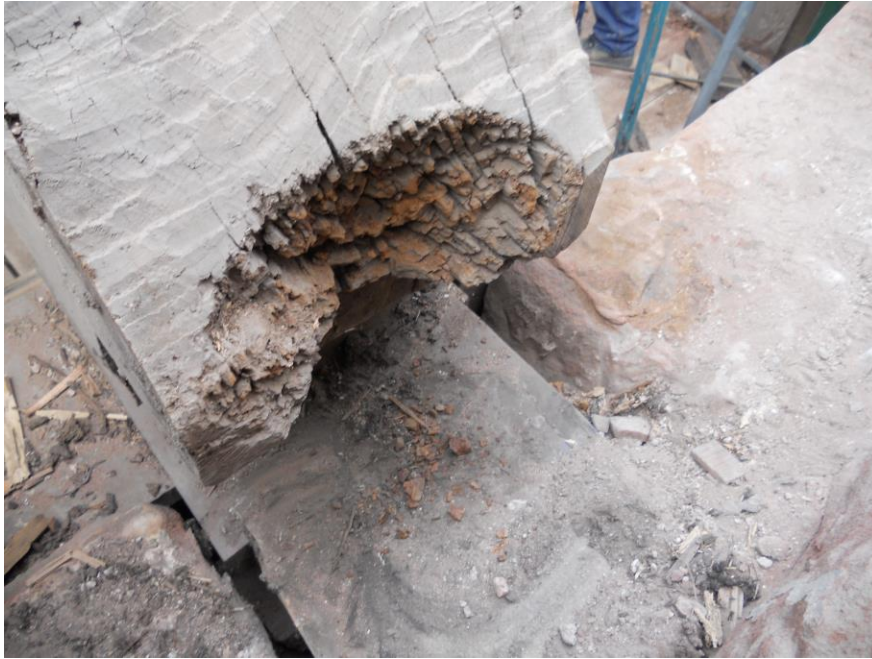
... and this is
wet rot.

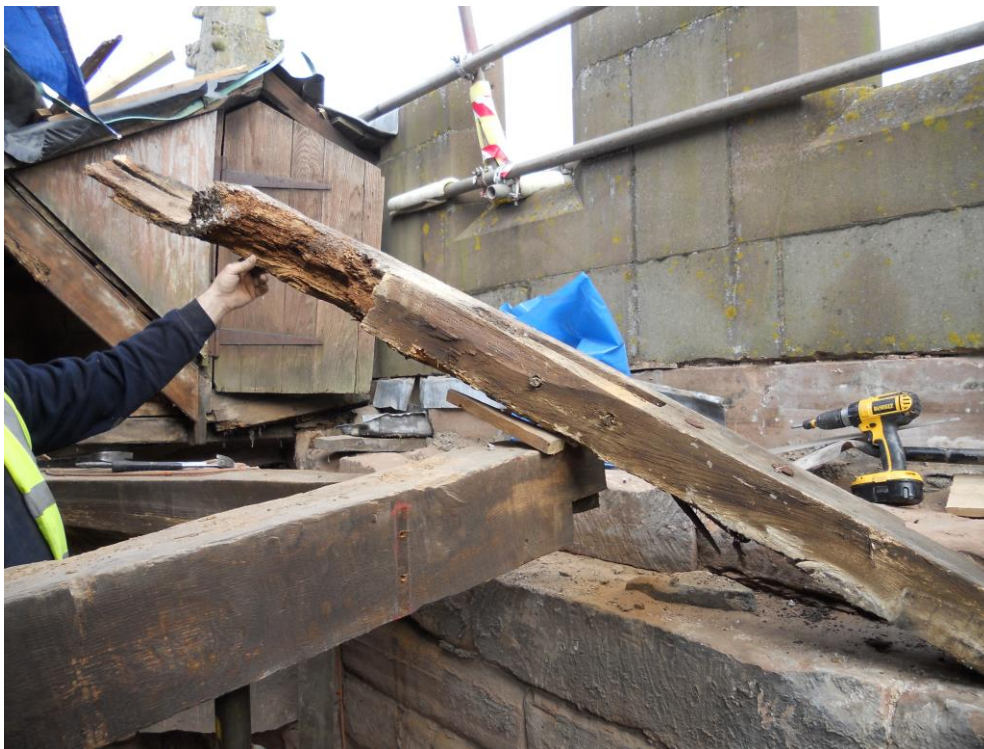
More rotten timber was hidden behind inaccessible areas. Now the whole wall plate and timber sub-structure will need to be replaced.

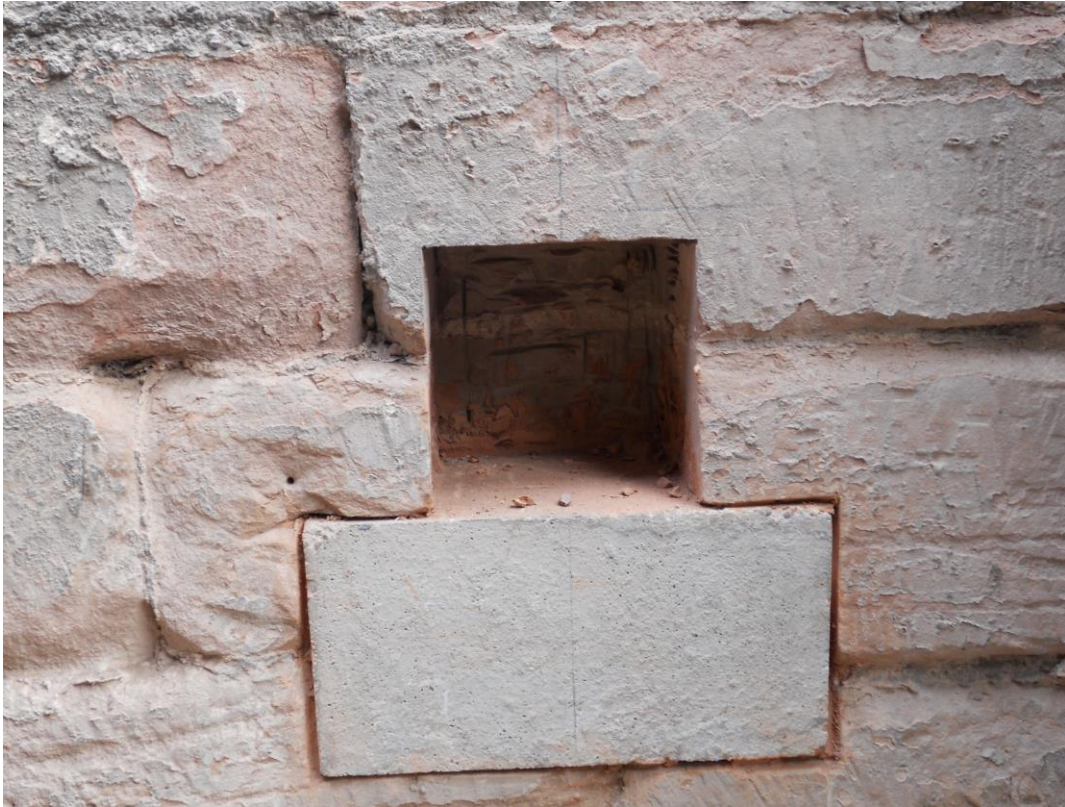
The stonemason has cut a hole to take the new steel support, which is to hold up the main roof beam.

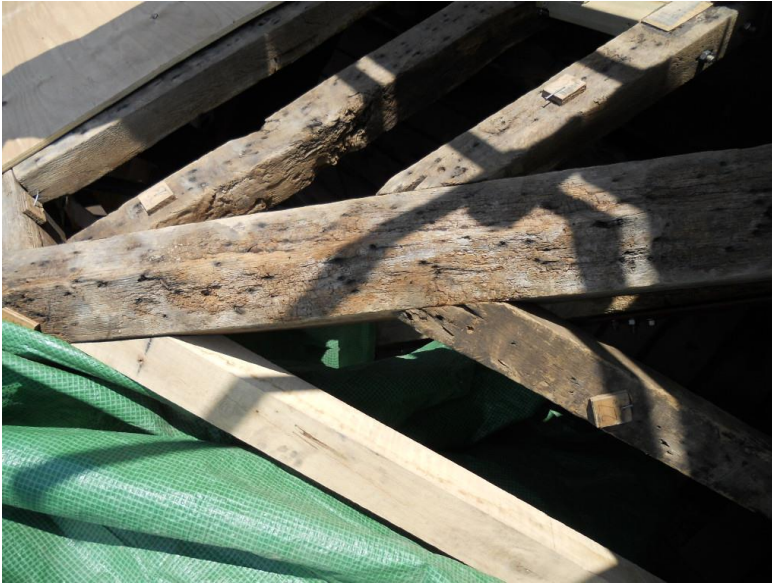
Although this timber looks rotten, it is just surface-worn, so is sound to be left in place.

The wooden boards are called “gutter carcassing” and will be waterproofed.

Then the roof will be felted and tiled.

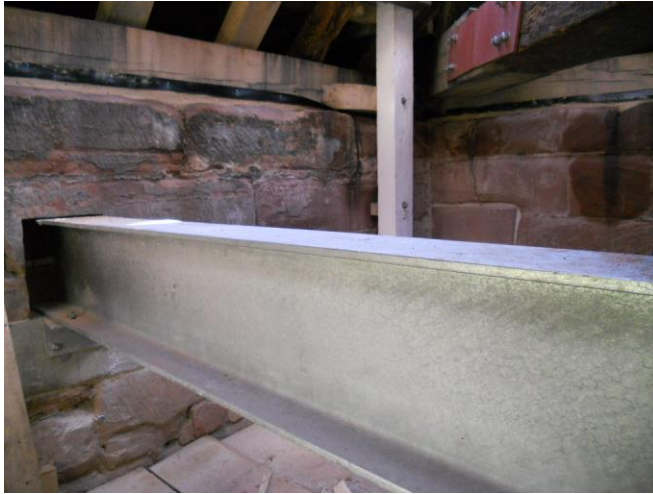
Steel beams have been inserted and secured at roof parapet level, and will support the existing wooden beams ...

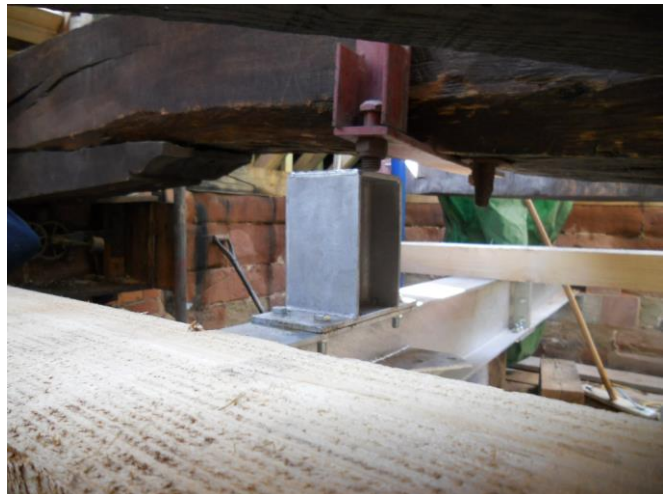
... and this slot is called a “stub”. It will secure a wooden beam.

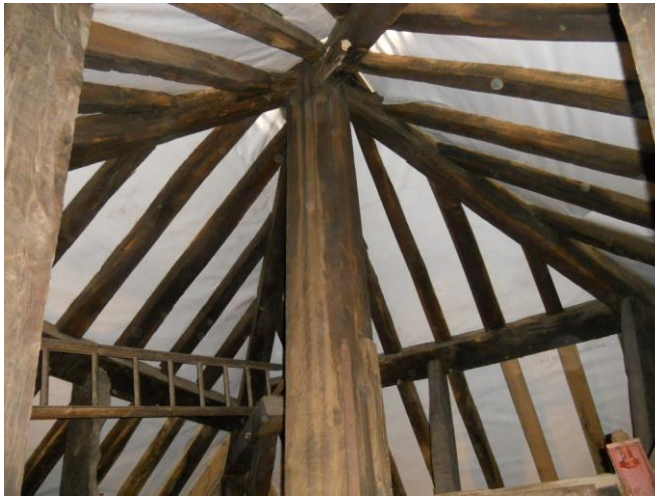
The rafters of the steeple have been felted with a modern breathable membrane.

The roof tiles are being replaced and will be completed next week.

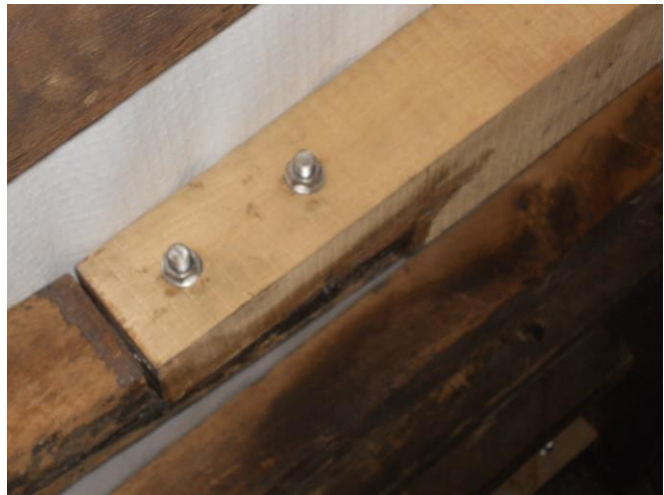
A new joint replaces the rotten wood inside the steeple.

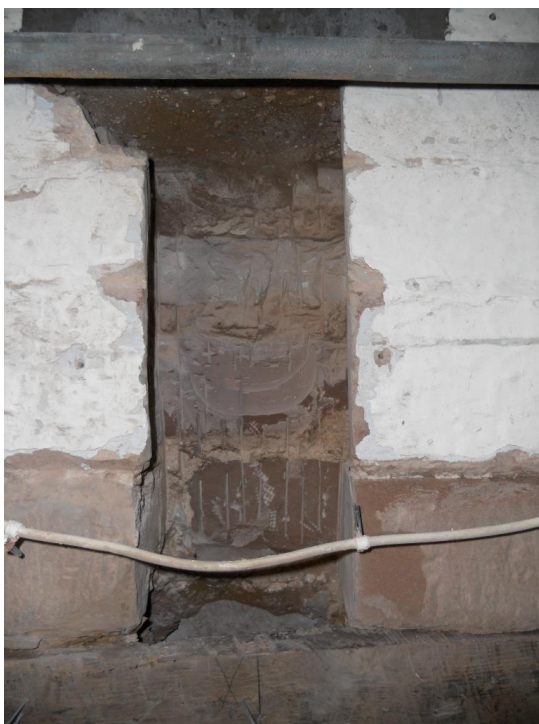
The padstones in the belfry have been tapered and roughened to provide a key to hold the steel support beams in place, and to withstand the up, down and sideways forces of ringing bells.

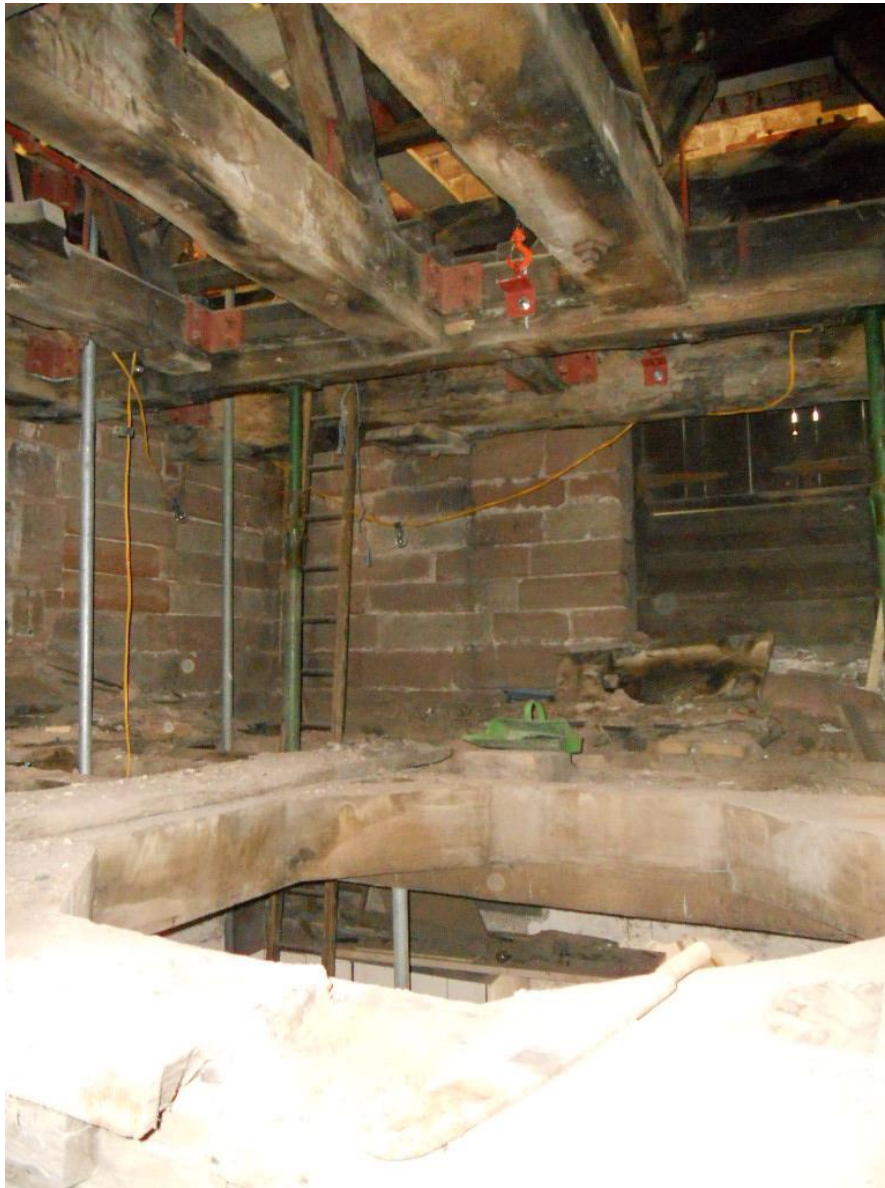
The bell frame has been lifted from its octagonal wooden support beams by about 4'. It is held on the chains fixed in the belfry.

This octagonal structure supports the bell frame from underneath and is never seen unless the bell frame is raised.

The belfry walls and timbers are now seen, and much more repair works are found to be required to both stone and woodwork.

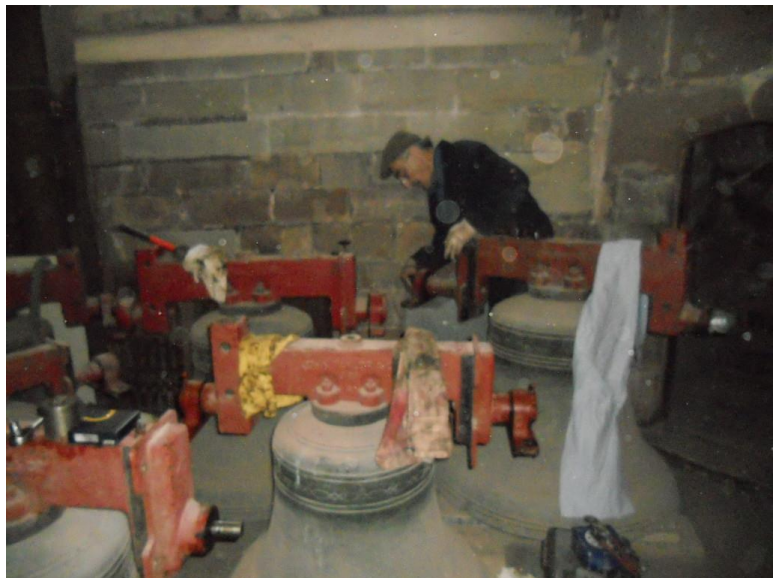
Bill Berry greases the gudgeons on the bell fittings before replacing the worn bearings.

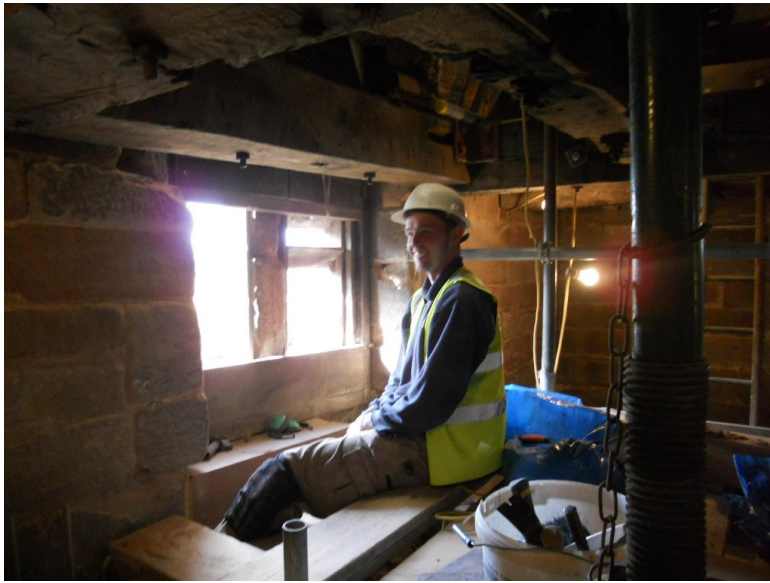
A window sill in the belfry is prepared for replacement stone.

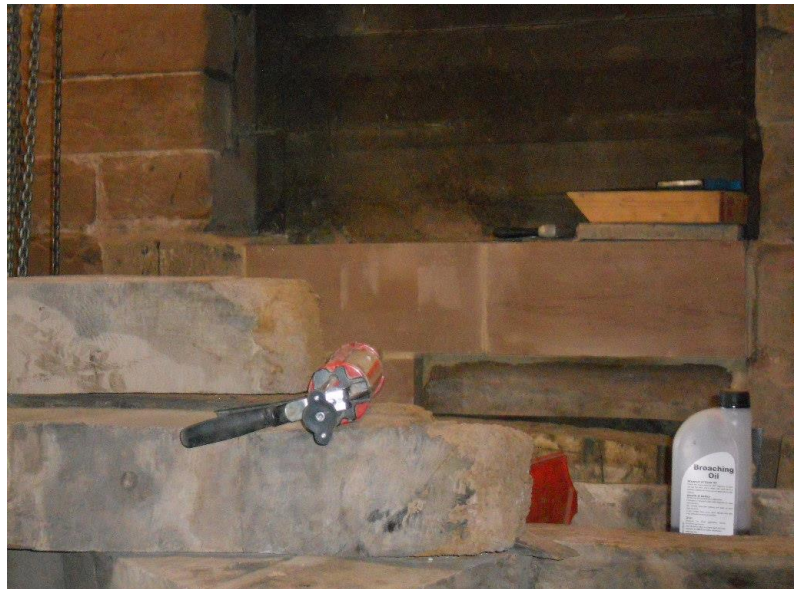
A completed stone
window sill repair.

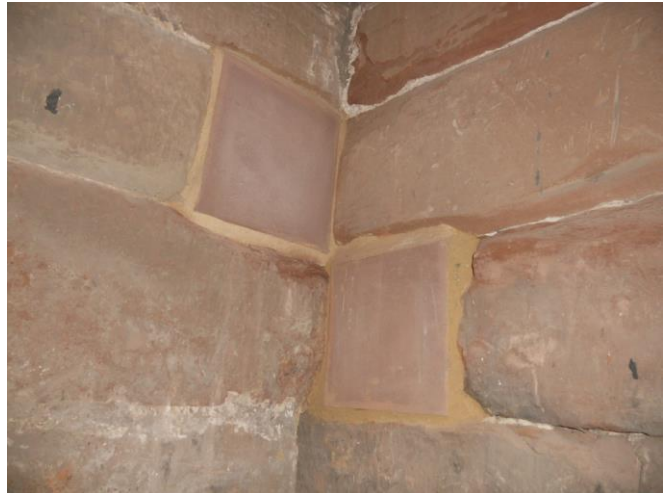
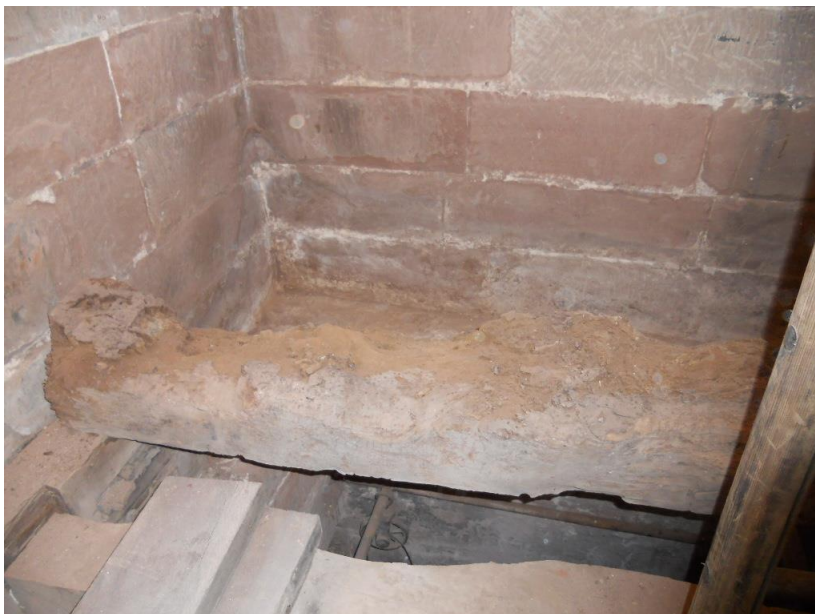
New red sandstone ashlars have been placed into the tower walls at belfry height.

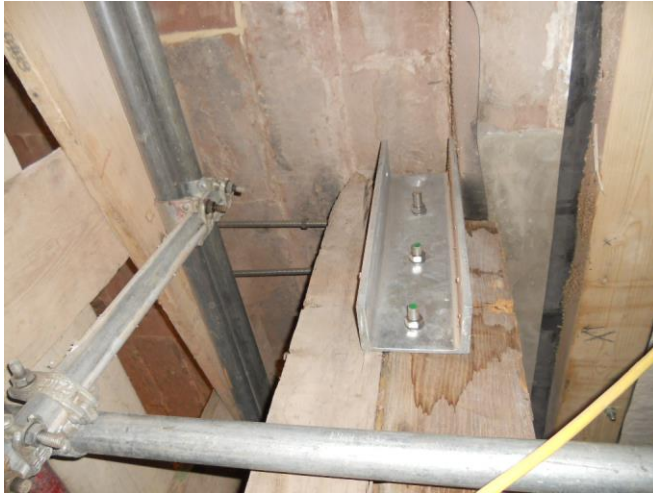
Worn timber foundation beam at belfry height.

Steel support bracing to timbers in belfry.
